Maanshan Unit 2 Steam Generator Water Level Oscillation and Cleaning

Department of Nuclear Regulation
Atomic Energy Council
May 31 & June 1, 2005

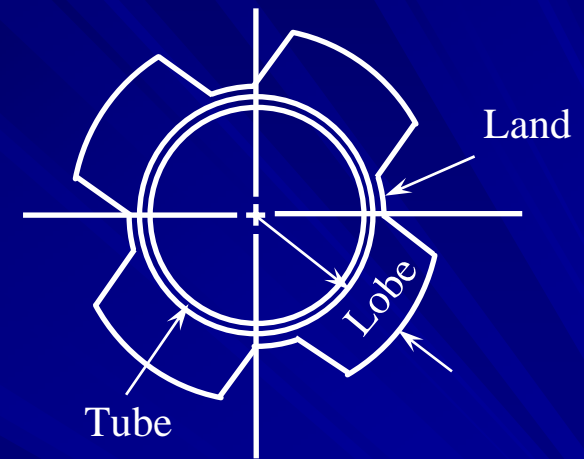
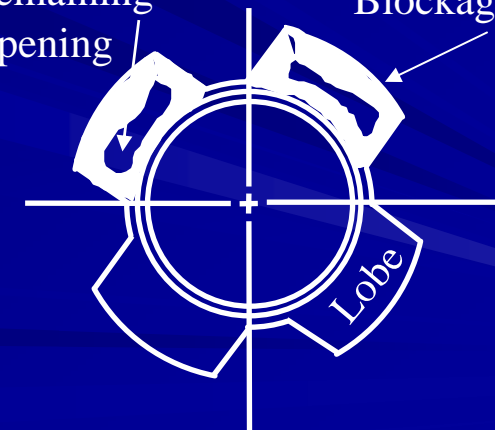
Blockage of Broach Hole of Tube Support Plate

Schematic of blockage in lobe

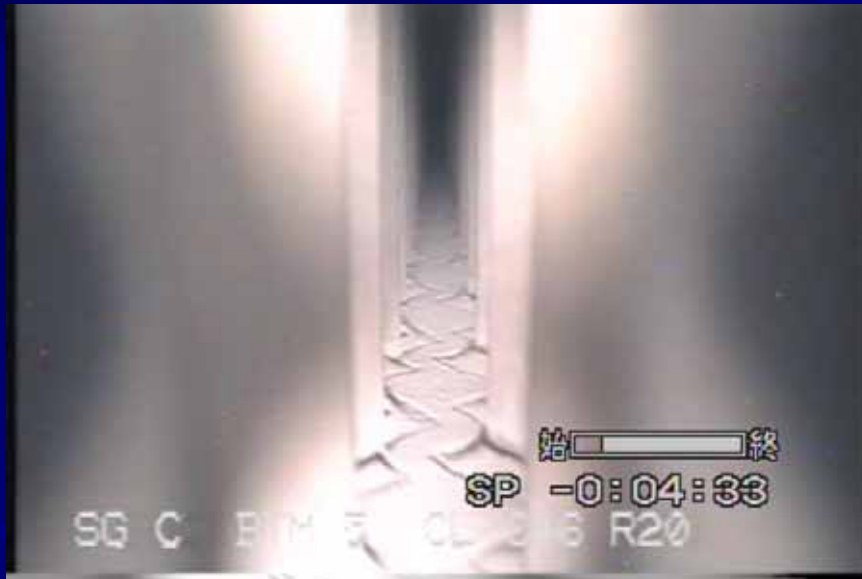
- Each S/G has been cleaned twice.
- Before cleaning, video pictures show that severe quatrefoil fouling for S/G B&C. UBIB inspection can not be performed at S/G A because of misalignment of flow-slots at tube support plate.
- After cleaning ,comparatively large amount of deposits have been removed, significant improvement of quatrefoil fouling cleanup is evident.

Severe Quatrefoil Fouling both Hot Leg and Cold Leg Sides

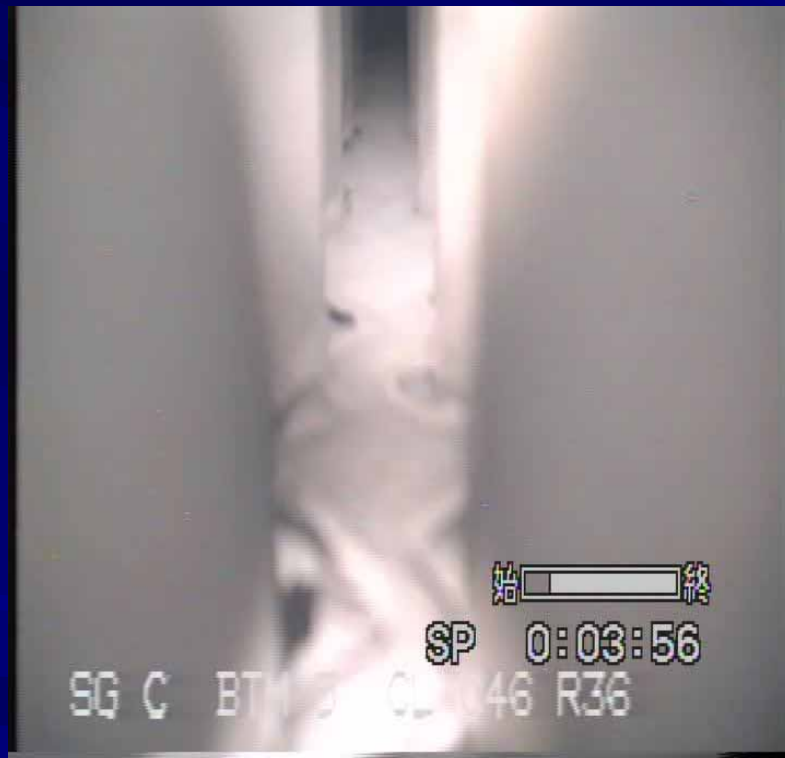
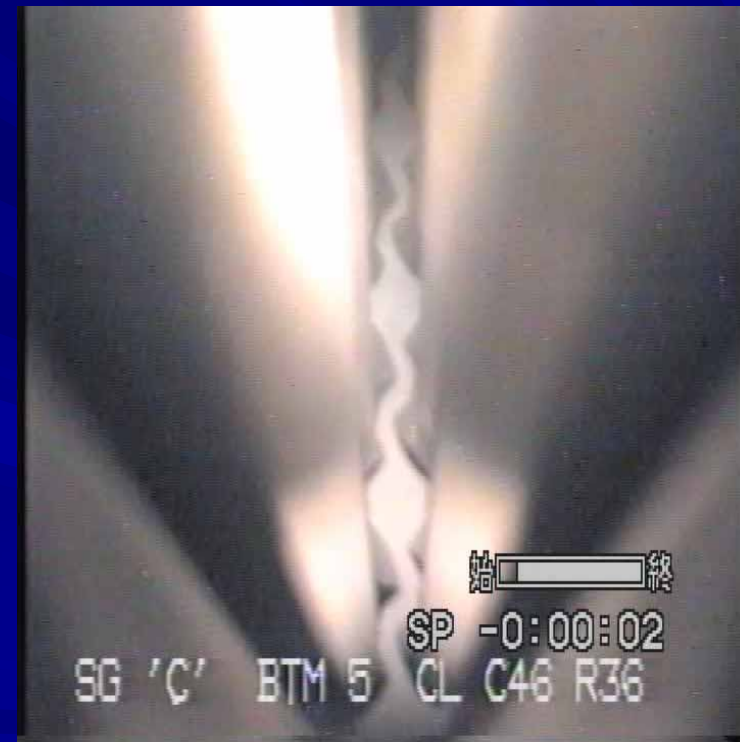
5th TSP Bottom

Comparison before and after Cleaning

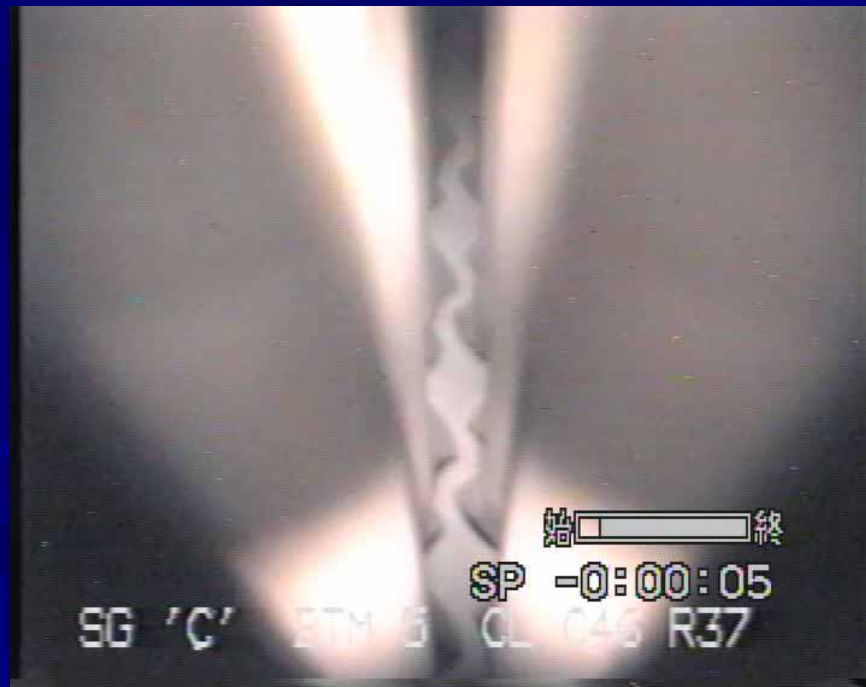
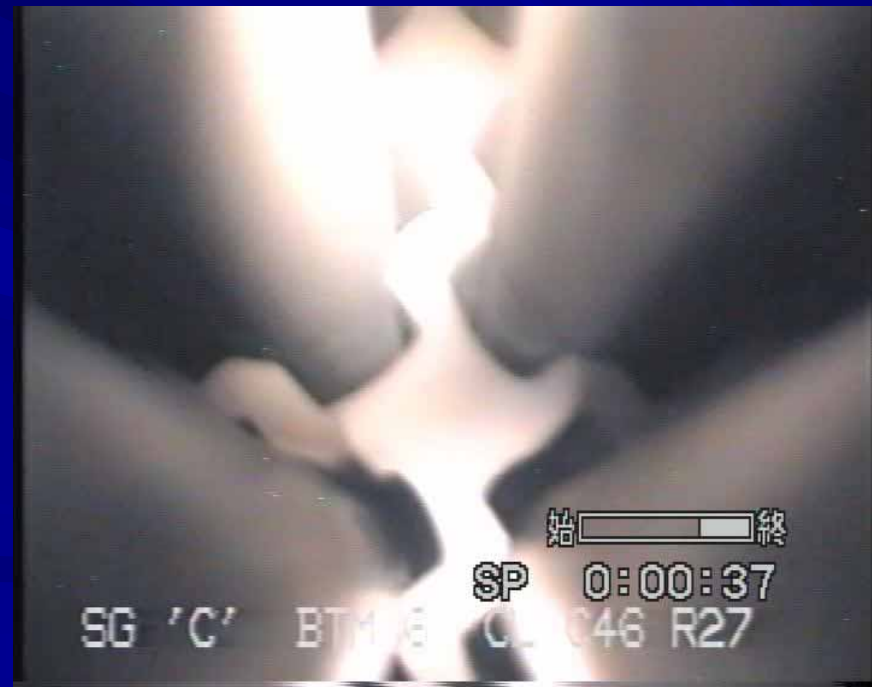
5th TSP BOTTOM

Quatrefoil Fouling has been removed

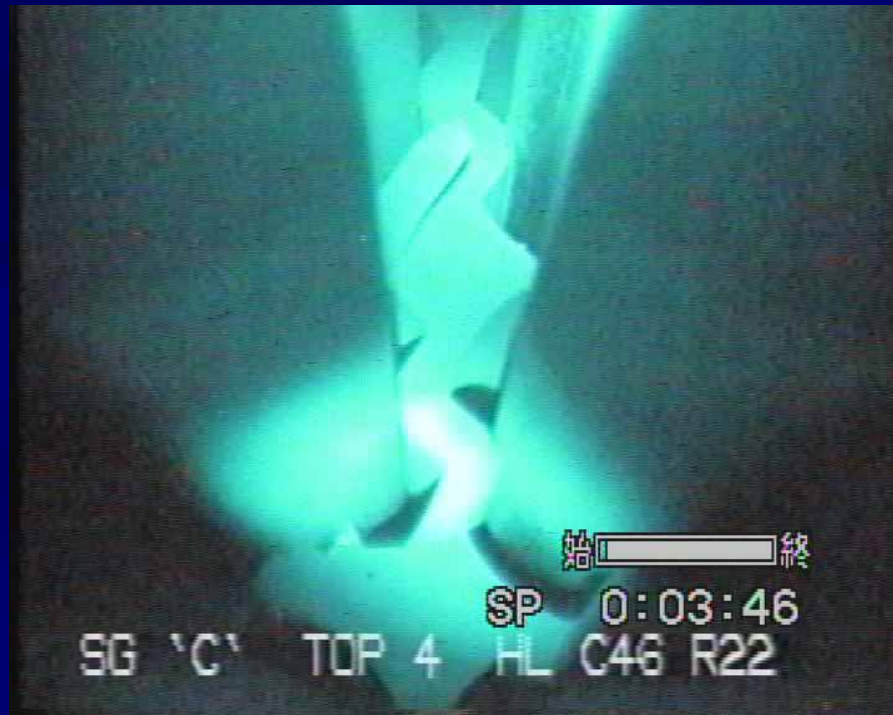
Scale on TSPs Less than Expected

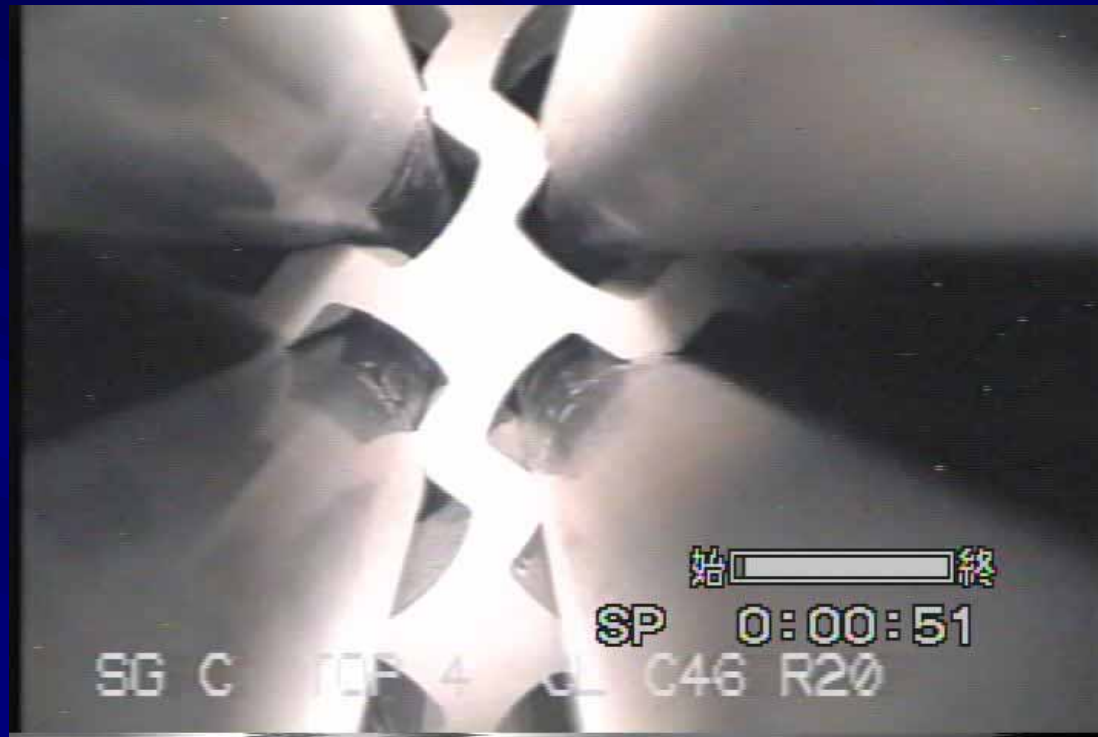
4th TSP

Top of TSPs Appear Clean

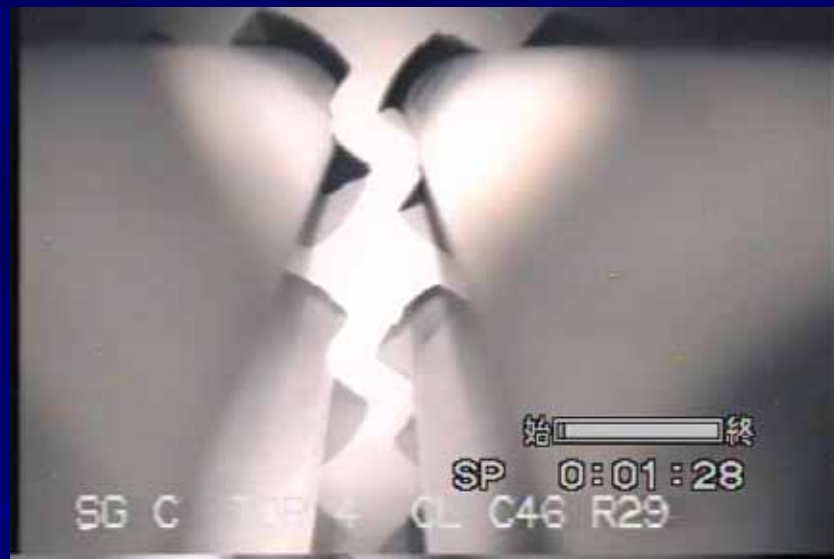
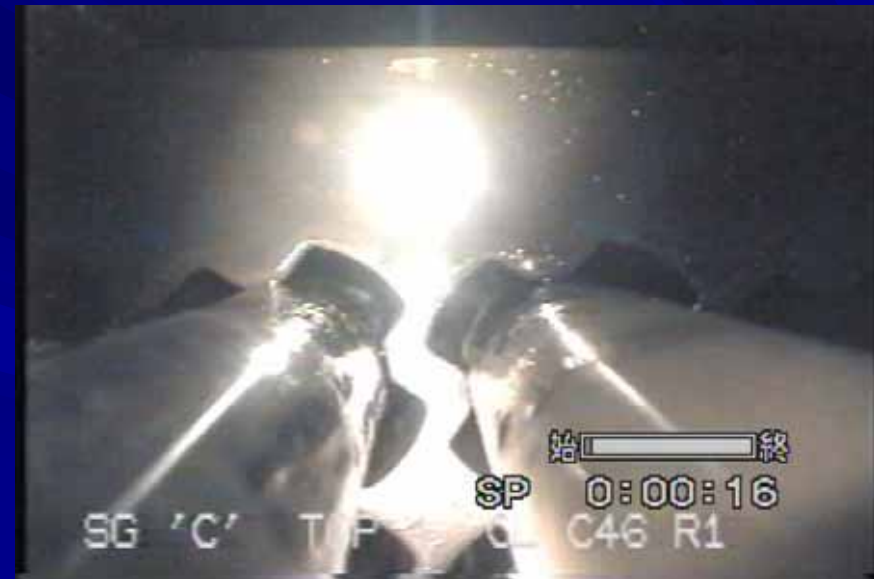
Some Tube Surface Deposits have been removed
