**Reportable Event Report on Maanshan Nuclear Power Plant Unit 1
Reactor Scram Arising from the Low-Low Water Level of Steam Generator
(RER-94-31-001)**

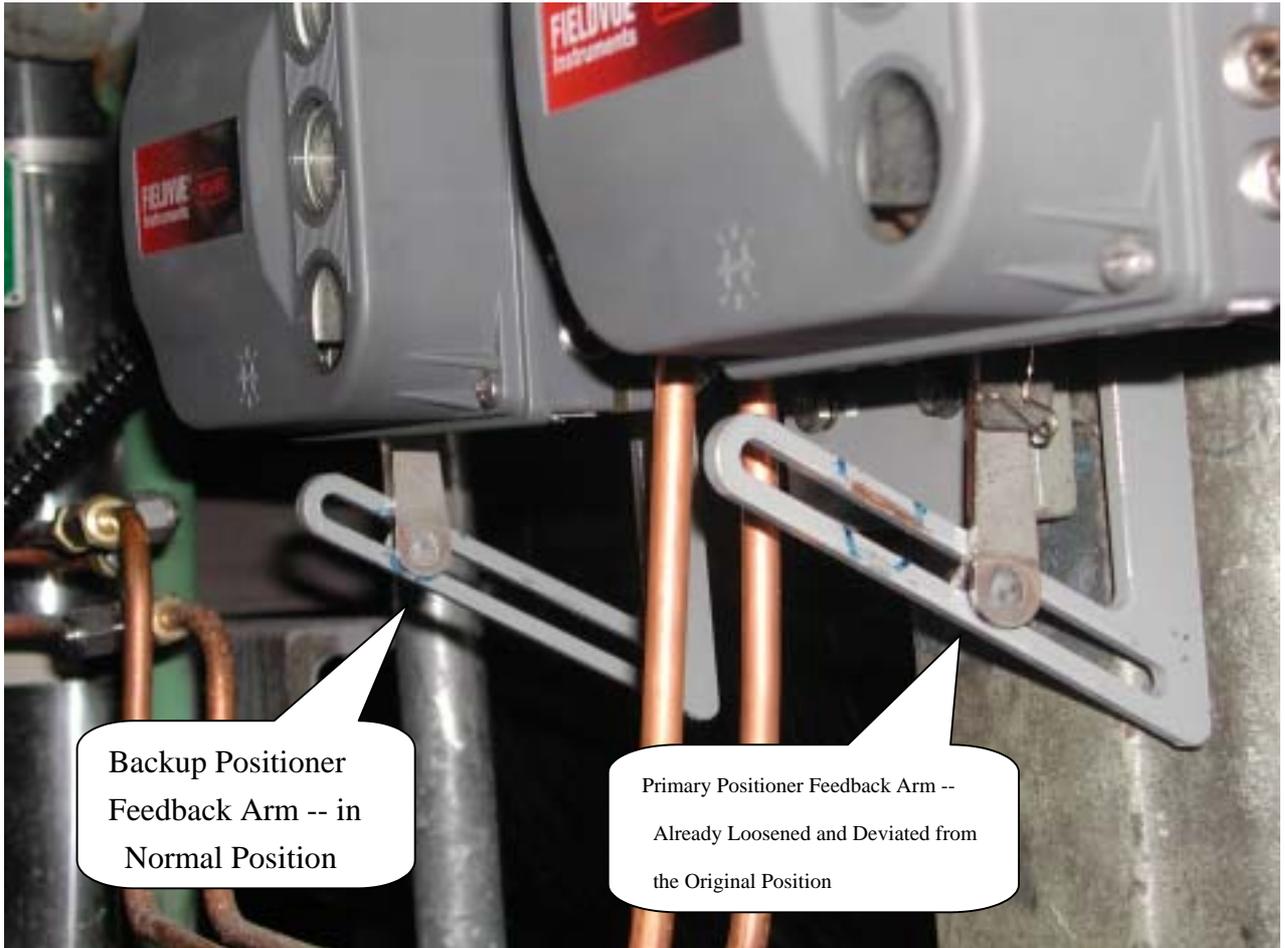
screws of the valve feedback arm came loose, leading to a loosening of the primary positioner feedback arm of the primary control circuit (see the attached photo), which in turn caused a loss of feedback signal on the positioner, the valve to be turned open, and the flowrate of the feedwater and water level of the steam generator to rise. During the period of abnormal rising water levels, the operator attempted to adjust water levels back to normal by manual intervention, but without success. Although the operator then tried to switch to the backup automatic control circuit, he could not put the system back to normal in time, so the reactor scram occurred on low water level of the steam generator.

Loosening of the Feedback Arm of Primary Control Circuit
Positioner of Feedwater Regulating Valve (AE-FV498)
(Photo taken after Reactor Scram)

Following the reactor scram, personnel at Maanshan Nuclear Power Plant already re-fastened the valve positioner feedback arm, spot-welded into a fixed position, and adjusted valve functions, as well as modified the other two circuits of the primary feedwater control valve, AE-FV478 and AE-FV488. Likewise, an inspection was carried out on Unit 2, making sure no screws have signs of coming loose. A plan has been underway to re-adjust on Unit 2 in the same way as Unit 1 refueling outage or proposing better setting alternatives. At the same time, maintenance personnel are scheduled to inspect the area -- where the primary feedwater control valves equipment are located -- once every week. As to training of operators, plans have been mapped out to revise a part of operating procedures as well as enhance operation training in relevant equipment.
