**Reportable Event Report on Maanshan Nuclear Power Plant Unit 2  
Steam Generator Low-Low Level Scram  
(RER-94-32-001)**

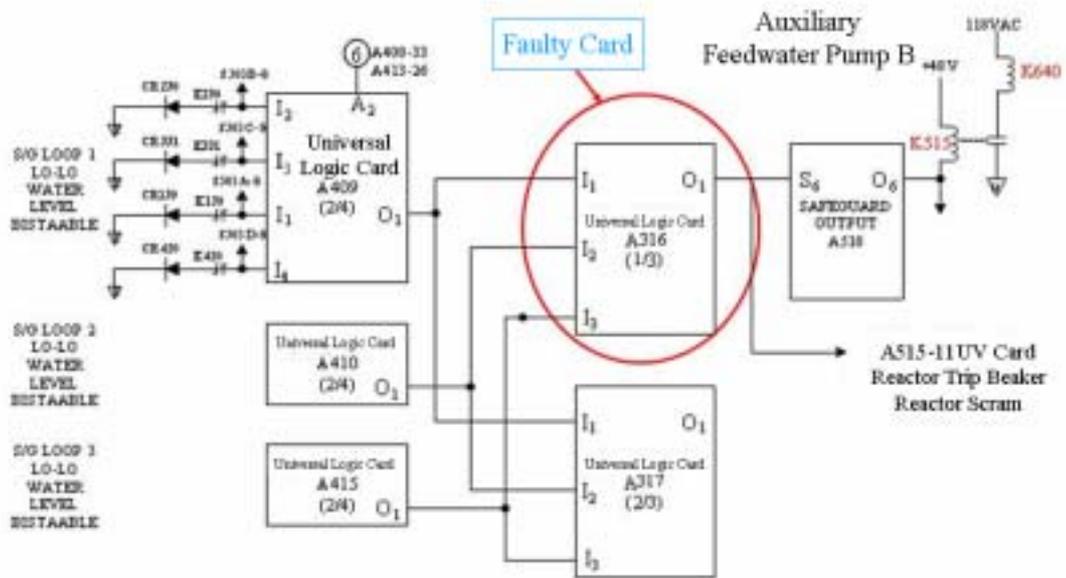
The cause of this reactor scram event was that the Solid State Protection System (SSPS) universal logic card (No. A316, low-low water level signal for the steam generators) malfunctioned (there was, in fact, no low-low water level condition) as shown in the diagram. This then caused the actuation of the Auxiliary Feed Water System (AFWS)/Train B and Reactor Protection System.

When measured with a multi-meter, the universal logic card A316 (O<sub>1</sub>) showed a voltage of 0.6 Vdc (Logic 1). Normally the voltage should be 14.78 Vdc. This voltage value showed that the universal logic card A316 was giving a trip signal, which was the signal for the reactor trip breaker and the motor-driven AFWS/Train B to be actuated.

Logically, the possible causes for sending the erroneous trip signal by the universal logic card A316 are: 1) the A316 card itself failed, or 2) the A316 card had problems in the input/output signal. During the investigation following the incident, however, the failure of the card could not be reproduced. Perhaps the cause of the failure was eliminated or disappeared when the A316 card was pulled out.

- 1) Examination of the A316 card slot and all the input/output solder connections in the equipment cabinet with an electron microscope to confirm there was no abnormality.
- 2) A renewed examination of the correctness of all input/output connections of the A316 card.

- 3) Change of the A316 card and all the input/output cards in series, including four universal logic cards, A316, A409, A410 and A415, as well as the safeguard output A518 card. Also the 600-I-SB-1002 test procedure (reactor protection system Train B logic circuits bi-monthly test) was carried out to ensure that the SSPS/Train B equipment was normal and operable.
- 4) The five replaced cards were sent to the CSIST for a high temperature screening test to identify the faulty part of the card.
- 5) Installed a recorder that continuously monitors the input/output signal of the A316 card.
