Reportable Event Report on Maanshan Nuclear Power Station Unit 2
Reactor Scram Incident
(RER-94-32-002)

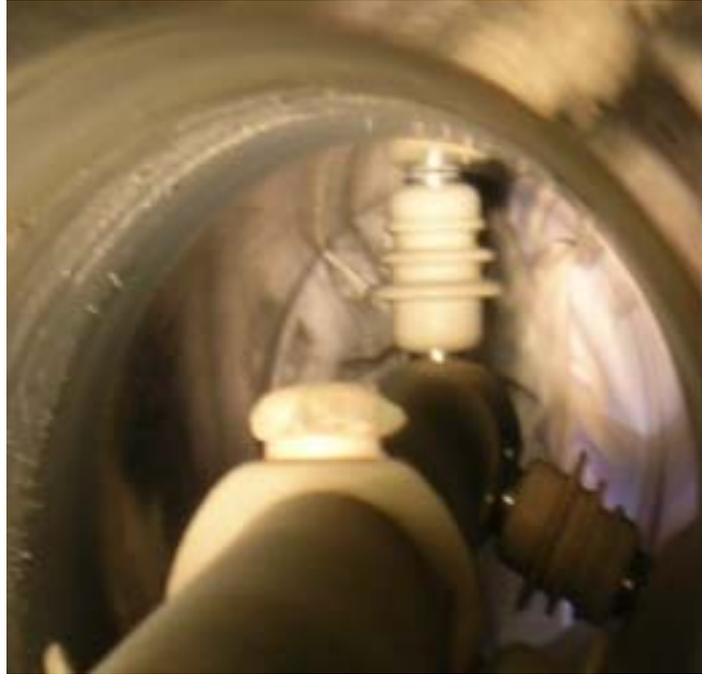
The cause of this event was a damaged support insulator (as attached picture) that caused flash over to ground in the section G2M12 of a gas insulated bus (GIB). This GIB led the phase B bus of the main transformer to the switch yard. The faulty current was detected by both the 587MT and 587U differential protective relays and they were consequently actuated, causing the main generator and the turbine to trip as well as the reactor to scram. This incident also actuated the Auxiliary Feed Water System (AFWS) and the Emergency Chilled Water System following reactor scram.

confirm that the cause of this incident was the flash over of the support insulator as described above. The switch yard transient data recorder showed that there was no system high voltage transient before the incident, thus the damage of the insulator could have been the result of deterioration rendering it incapable of handling the normal operating voltage. After the failure of the insulator, it broke into pieces. From a preliminary reconstruction of the pieces it was discovered that internally there were some black burn traces. This was the result of a large amount of current whose electro-magnetic force caused the disintegration of the insulator. On the basis of the insulator's damaged condition and up-to-date data, the preliminary conclusion is that the root cause could be that the insulator was somewhat cracked or creviced, rendering insufficient voltage carrying capability and thus causing flash over to ground. The determination of a definite cause awaits further laboratory analysis.

Damaged Insulator at 0° Position

After this incident, Maanshan Nuclear Power Station inspected and repaired the affected GIB, including: (a) replaced the insulator in the failed GIB section and repaired the conductor and piping, (b) all contaminated GIB sections were cleaned and reassembled, (c) after reassembly, the GIB underwent insulation tests and a step-up voltage test (to 105% of rated 345kV).

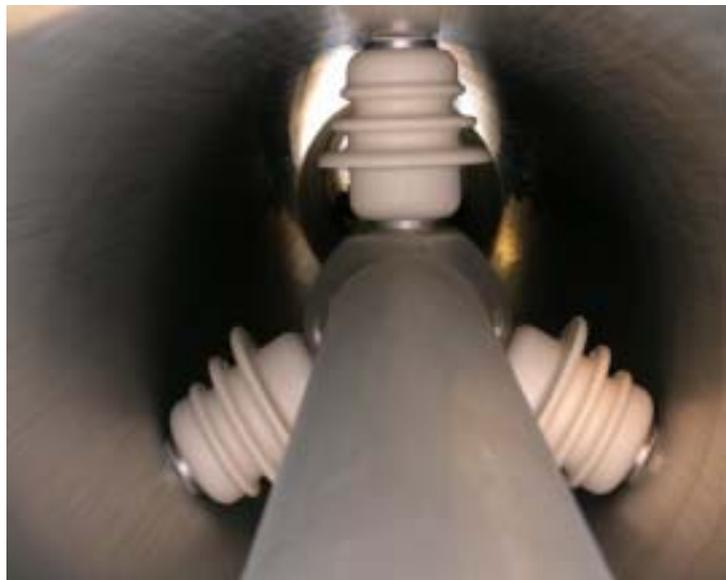
Normal insulators separated by 120 degrees.
