**Reportable Event Report on the Maanshan Nuclear Power Plant Unit 2  
September 8 Main Steam Line Low Pressure Incident that Triggered  
the Actuation of the Main Steam Isolation and Feed Water Isolation,  
and the Reactor Trip Signals**

**(RER-94-32-003)**

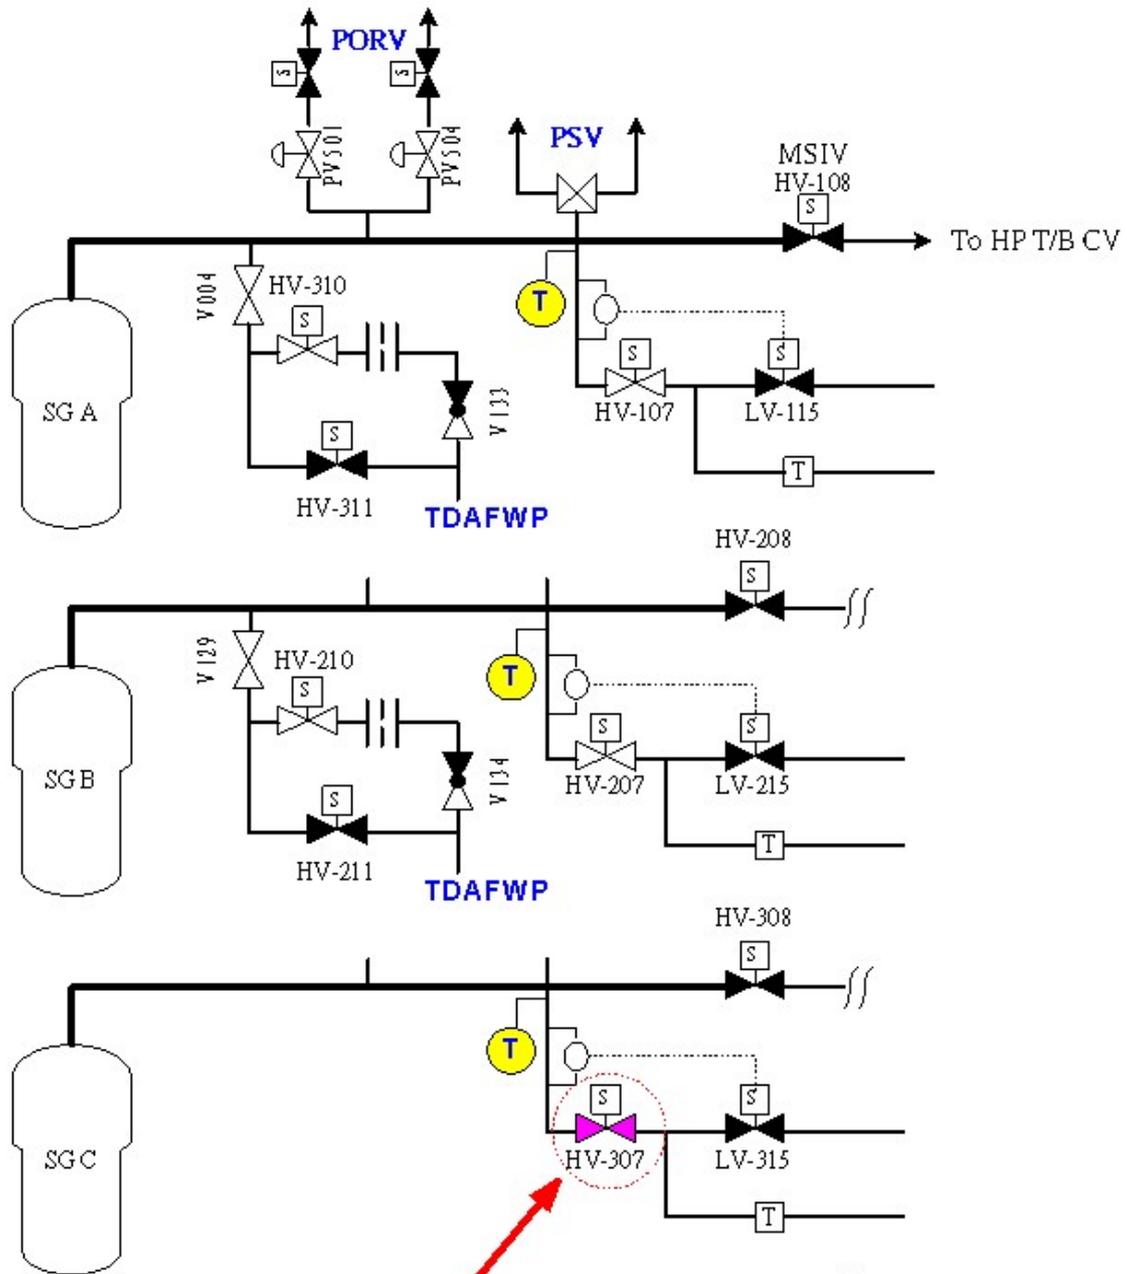
Diagram: Location of Drain Valves in the Steam Line

It was deduced that the cause triggering this safety system actuation and the generation of the reactor trip signal was originated from the destruction of the condenser vacuum and isolation of boundary, in order that personnel of the Maanshan Nuclear Power Plant could conduct repair work on the secondary side peripheral equipment on September 2. Because of leakage on the MSIVs, the personnel opened the MSIV downstream drain valves to release steam to the atmosphere; moreover, the personnel also shut the main steam line drain isolation valves AB-HV107/ HV207/HV307 (see attached illustration) to keep

steam release away from the condenser. This measure caused water accumulation in the steam lines, and in the subsequent transient stage, it triggered a water hammering problem, thus causing pressure transient that resulted in the low pressure condition of steam line C. However, further investigation and understanding is required to determine the true root cause of this problem.

This reportable event was due to the accumulation of water in the main steam lines after the drain isolation valves AB-HV107/ HV207/HV307 were shut. In the subsequent transient stage, it triggered a water hammer, an effect that has been verified as a clear cause of the problem. However, after the occurrence of the reportable event, it was found that many main steam line safety valves were activated at the time of event. Furthermore, a drift was noted in the trip setpoints of two safety valves. It is imperative to understand the correlation of this drift to the reportable event.

- Main steam lines A and B continue to supply heating steam to the turbine-driven auxiliary feedwater pump. The loop C design does not contain this design function.
- If the unit is kept in warm standby condition for a long period, and the drain valve is isolated, as a result of which, water may be accumulated in the pipes.

Maanshan Nuclear Power Plant instituted the following corrective measures after the actuation of the safety system: (1) Rechecked to ensure that all the bonnet bolt nuts and adjusting bolt nuts of the main steam safety valves (15 valves) are not loose; (2) Perform a Magnetic particle Test (MT) on the springs of safety valve AB-PSV302, 303, 304, and 306 to verify whether springs contained cracks or breakages; (3) Ran a main steam line C pipeline support and framework integrity test; test results reported normal status; (4) In the future, MSIV leakage condition should be verified during the outage inspection period of the unit; improvement measures instituted should be determined by the requirement of circumstances; (5) Amend the GOP procedures 202, 203, 204, 210, 211, 212, and 216: drain isolation valves AB-HV107, HV207, HV307 of the main steam lines should be kept open to prevent condensation related water accumulation in the steam pipes. In cases wherein the secondary side is under inspection and thus the water in the drain pipeline could not be drained to the condenser, the drainage

pipeline should be rerouted out of the turbine building, thus keeping the drain pipelines of the main steam lines unobstructed; and (6) Include the reportable event into the training course program of duty personnel (including the classroom and simulator training courses).
