The Station Blackout Incident of the Maanshan NPP unit 1

Atomic Energy Council

April 18, 2001

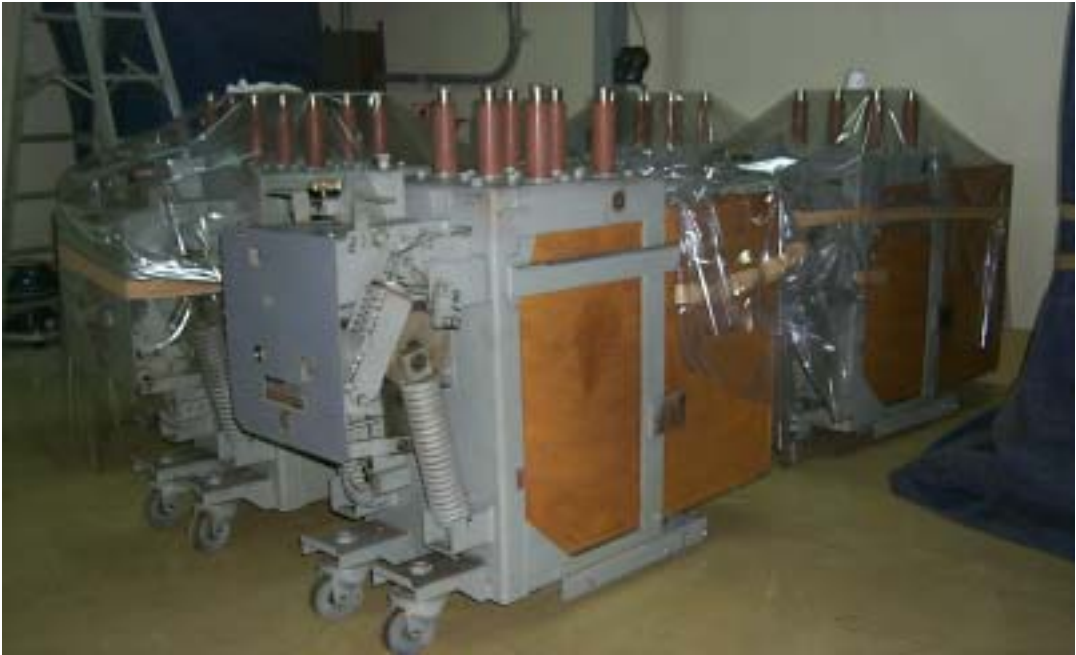
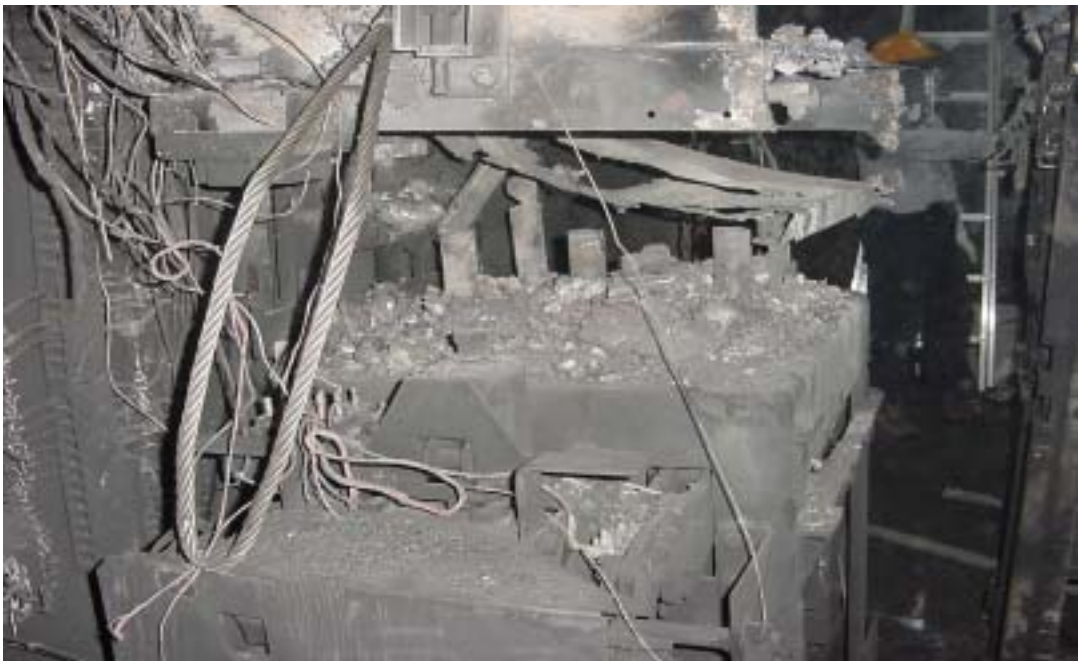
Photo 1: normal v.s. damaged breaker

The # 15 and #17 breakers on the 4.16 KV essential bus A were seriously damaged (as shown in photo 1 through photo 3). From the readings of the breakers' voltage before the incident (between 00:41 and 00:45), the 161 KV bus remained available (as shown in Figure 2). It was first determined that breaker #15 cannot be the first fault. This is further evidenced by the fact that breaker 3620 closed at 00:45:06, and consequently breaker 3510 tripped to open at 00:45:07. As a result, breaker #17 must be where the initial fault occurred.

Looking through the switchgear room of the 4.16 KV bus A, the bus end of breaker #17 was visibly undamaged after the incident. In addition, conditions of the power side connection end revealed that breaker #17 was damaged by over-voltage instead of over-current. This result reasonably matches the event sequence that breaker #17 was at open position before the incidence, and then incident occurred when breaker 3620 closed.

Based on the finding that the incident occurred when breaker #17 was at open position and that the site situation was possibly caused by over-voltage, the root cause of the incident is judged to be insulation degradation of breaker #17. Because it is found that the B-phase electric connection end at the power side of breaker #17 is the most damaged location, it is reasonable to assume that the B-phase connection end insulation was degraded before the incident. At 00:41 March 18, it is possible that an electric arc took place locally at breaker #17 during the over-voltage shock resulted from the loss of offsite 345 KV power. The local electric arc made the ambient air ionized. The ionized air was contained inside the cubicle. At 00:45 (4 minutes later), the recovery of the offsite 345 KV power made breaker 3620 to close. The transient voltage from the 345 KV system finally burned out breaker #17. Because the buses were seriously damaged, it is not easy to collect all evidence. The possibility of mechanical fault of breaker #17, on the other hand, may not be completely ruled out.

Damaged Breaker #17

(2). TPC must review and improve the surveillance program for the breakers of all essential buses.

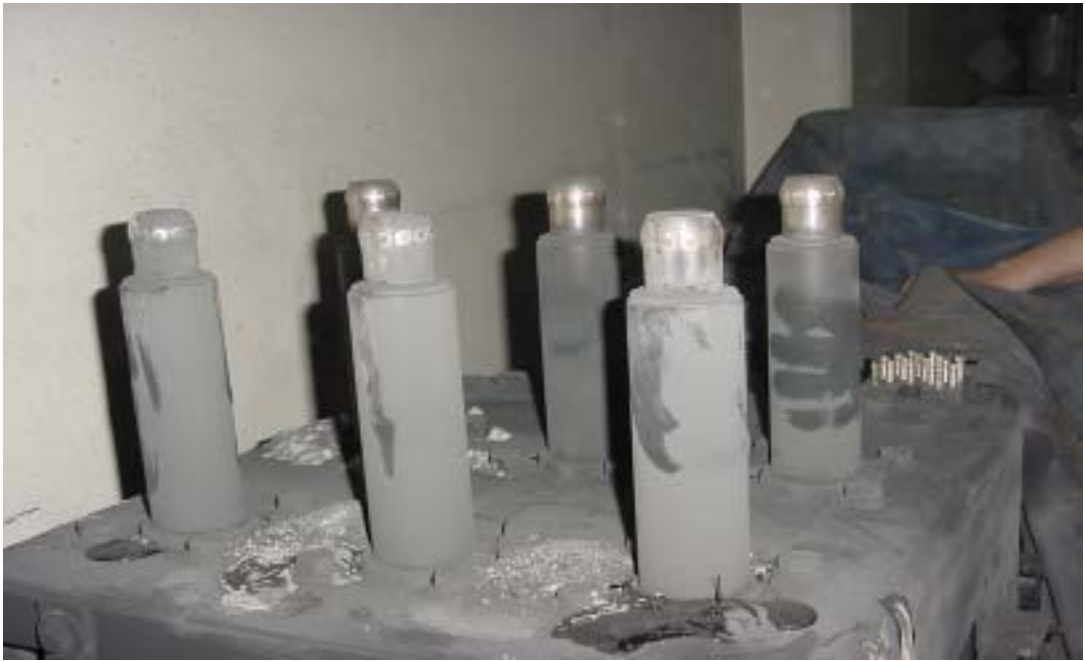
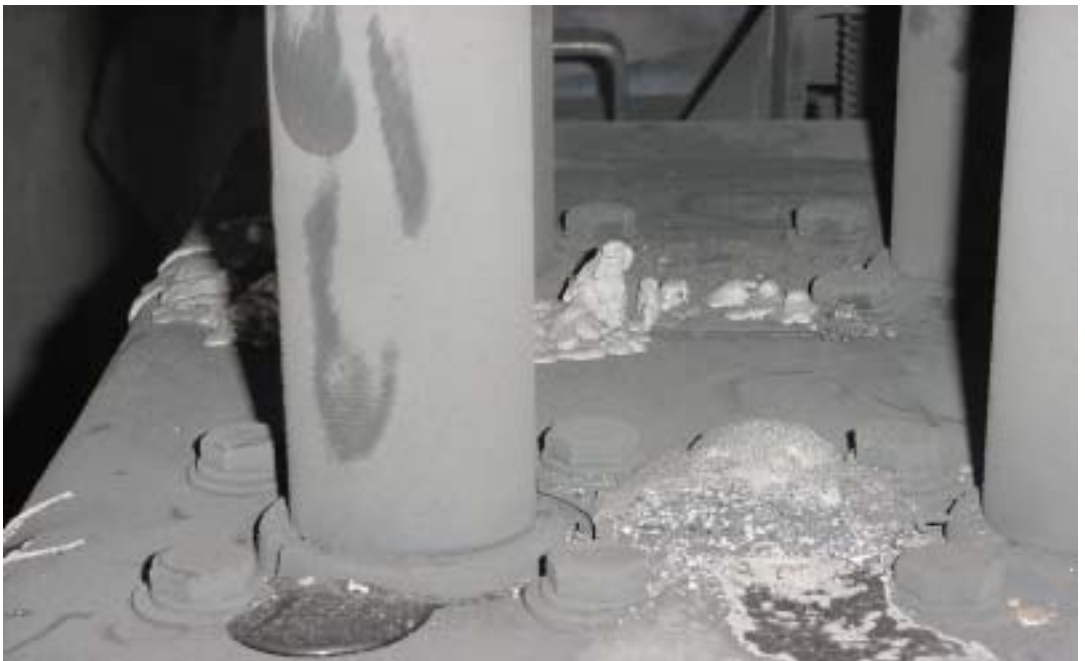
Photo 2 : damage conditions of breaker #15

Based on the aforementioned judgments, the possible incidence sequence should be: breaker #17 on the 4.16 KV bus A had a grounded fault at the power side, inducing electric arc and burning out the breaker #15 (close to breaker #17) , and subsequently causing grounding of breaker #15 at the power side. Then the 4.16 KV bus A failed due to bus grounding. This led to both breaker 3510 and breaker 1670 to trip and both the 345 KV and 161 KV offsite sources could not supply electric power to the 4.16 KV essential bus B.

Connector damages of breaker #15

Frame damages of breaker #15

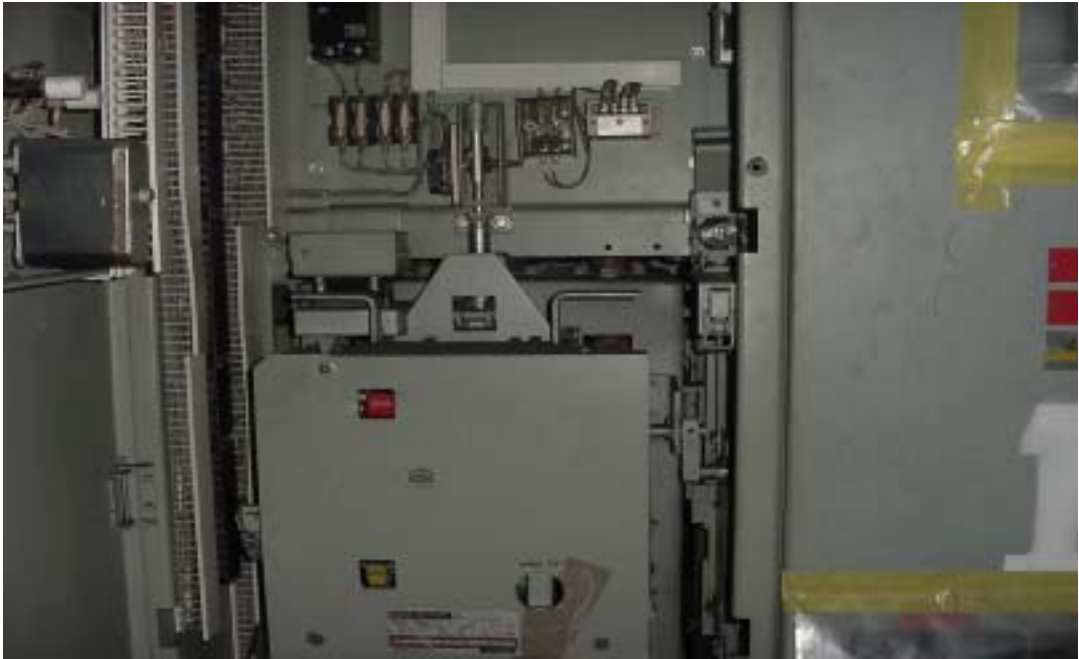
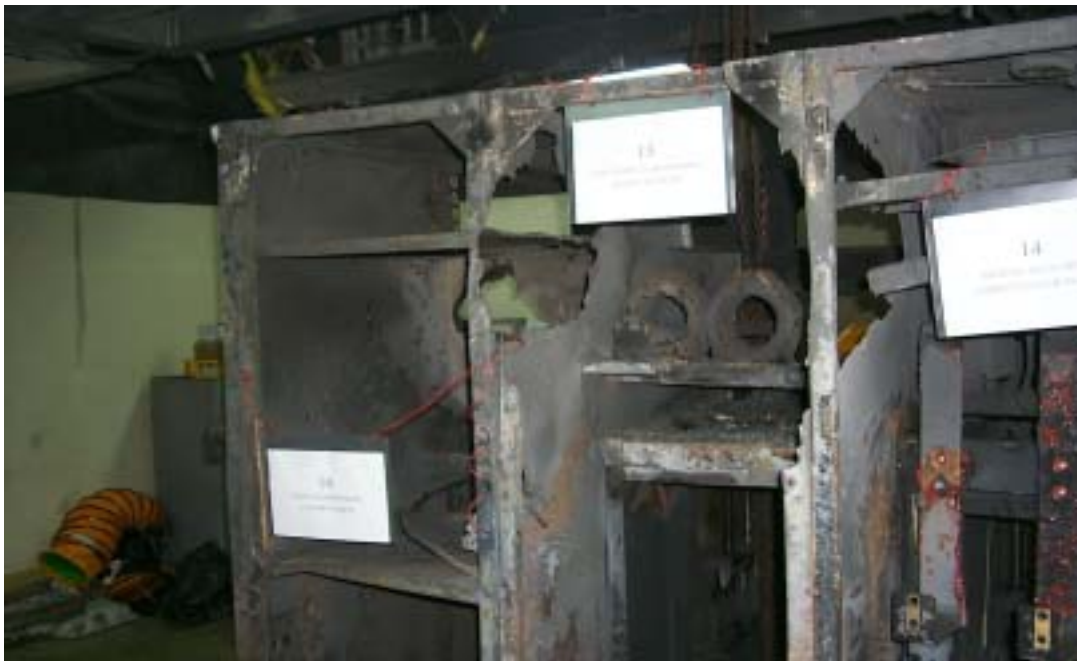
Photo 3 : normal v.s. damaged switchgear

Damaged essential 4.16KV bus switchgear

(1). Maanshan plant must improve the power supply scheme to essential buses to ensure system independency and redundancy.

(3). Maanshan plant must review and improve the design adequacy of their electrical protection system.

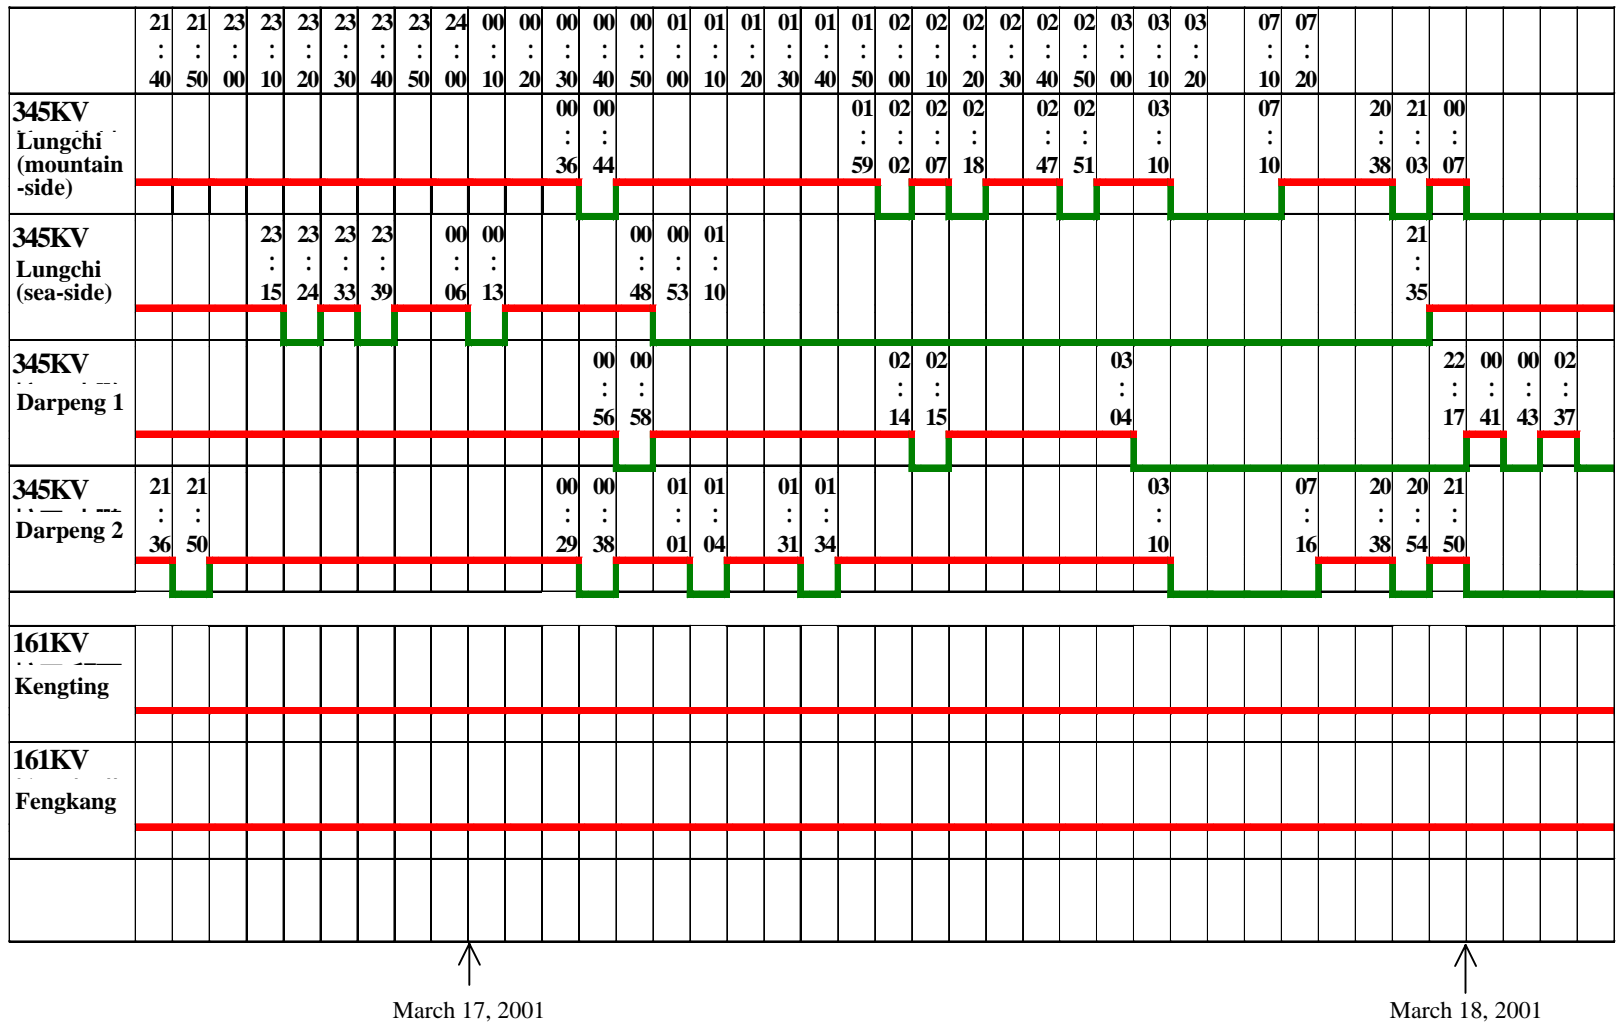
Figure 3: Offsite power situation before the Maanshan incident

One possible reason for causing insulation degradation of breaker #17 is the instability of the offsite 345 KV power system (see Figure 3). According to certain analyses, when transient by the 345 KV transmission system occurred, the voltage shock to the connection end of

breaker #17 can happen. This voltage can be in the range between 7 KV and 9 KV. The accumulated effect by voltage shock probably causes the insulation degradation.

TPC must thoroughly resolve the salt deposit problem onto transmission lines connecting to the Maanshan plant.

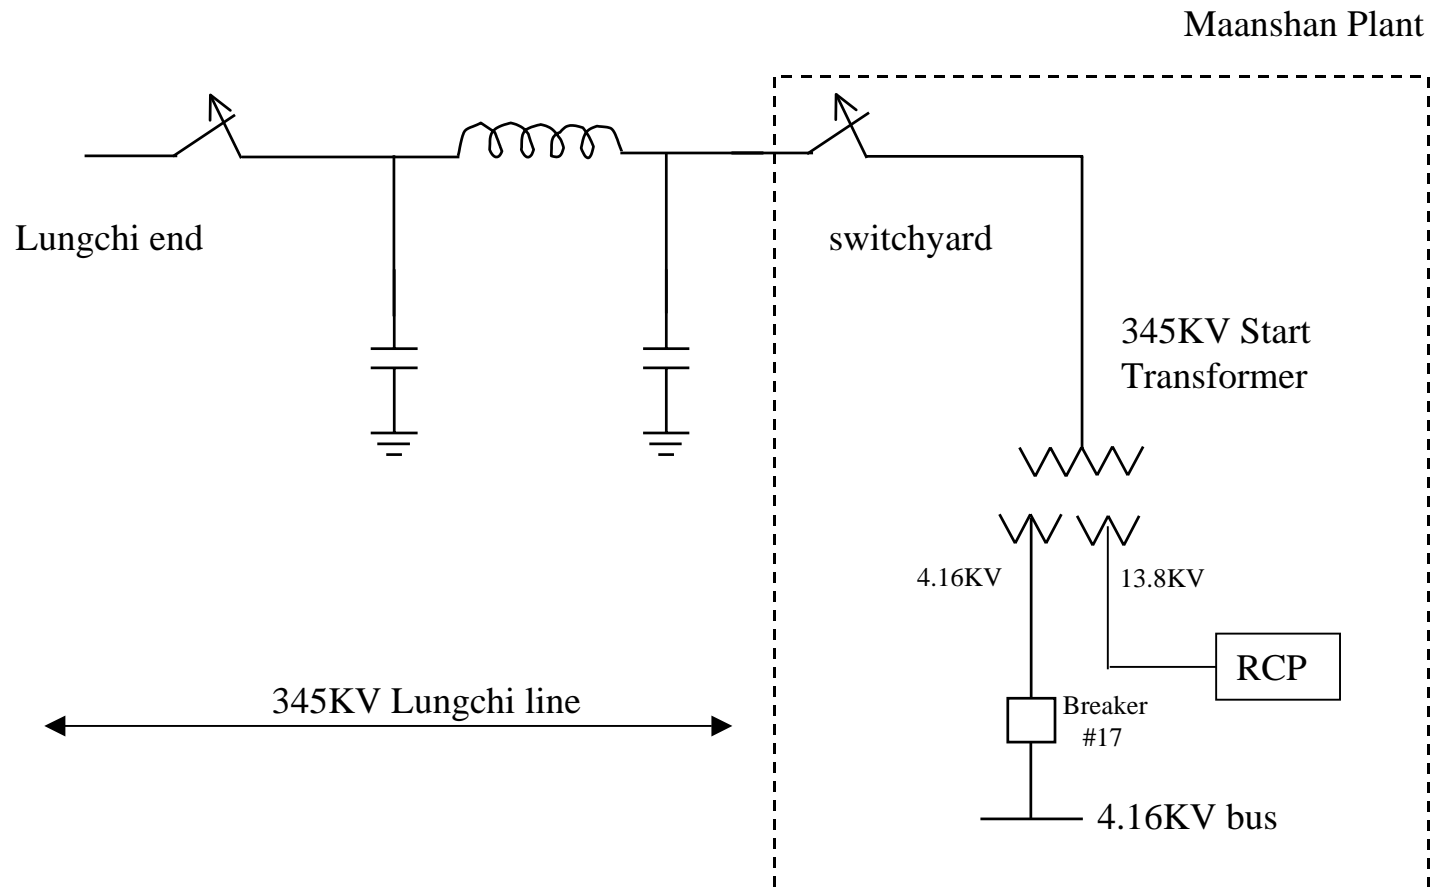
Figure 4: Ferro-Resonance of 345 KV Transmission System

Another possible reason for causing insulation degradation may be the resonance of transmission lines (Ferro-Resonance). At 20:38 March 17, the offsite 345 KV power system tripped (Figure 4) but the corresponding breakers (breaker 3520 and breaker 3530) did not trip to open. Because the transmission line of 345 KV system to Maanshan NPP is quite long, the interaction between the equivalent capacitor, equivalent conductor, and equivalent impedance of Maanshan NPP startup transformer made the resonance phenomena to happen. Since both units of Maanshan were at shut down condition while the 345 KV system tripped at 20:38 March 17, the 345 KV system should be at off power. However, the switchyard transient recorder at Maanshan NPP indicated that the 345 KV system still had voltage reading for 2 seconds at that time, and the reading was beyond the recorder scale.

The flywheels motion of the Reactor Coolant Pumps (RCPs) of Maanshan NPP was another possible cause for transmission line resonance. At 20:38 March 17, Maanshan NPP lost its offsite 345 KV power while the flywheels of all three RCPs were still rotating due to residual momentum. The driving motors reversibly turned into electric generators and produced reverse power to the 13.8 KV bus, resulted in voltage increase at the 345 KV system through the startup transformer. Consequently, this high-voltage impulse caused severe degradation to the insulation of breaker #17.

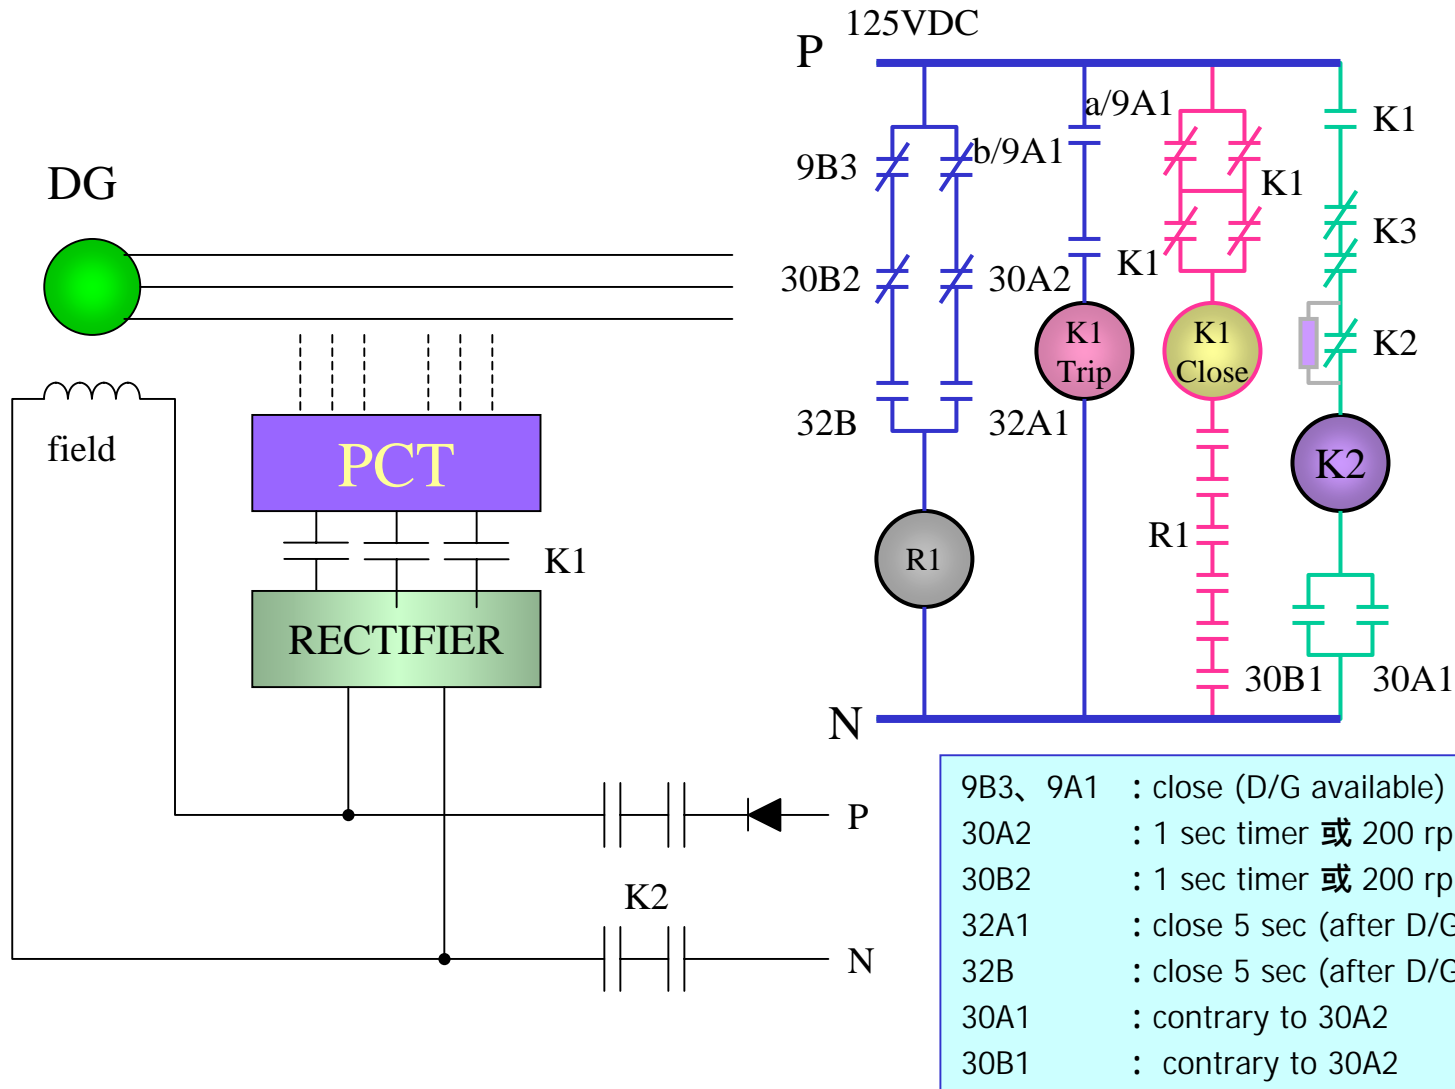
Figure 5 : EDG excitation control circuit

designed, but cannot establish excitation to generate voltage (Figure 5). The EDG B did start up but fail to supply AC power. After the incident, plant staff restarted the EDG B at 12:50 March 18, it started up successfully and the excitation also functioned properly.

After the incident, Maanshan NPP staff repeatedly tested R1 and K1 relay control circuits of the EDG B. Among those tests, the safety signal from both train A and B are isolated and tested separately. The test results show that when train A was tested alone, the electric magnet valve 141-2A had little air leakage. When train B was tested alone, the electric magnet valve 142-2B did not work (Figure 6). But when both train A and B were tested simultaneously as designed, the EDG got proper excitation and functioned normally.

According to the procedure, the electric magnet valve 141-2A and 142-2B shall be replaced for every three refueling outage (about five years). The most recent replacement was on May 2, 2000 and both valves were tested and verified to be functional conditions. During this incident, EDG B could not excite. The reason was judged to be the sluggish actuation of the electric magnet valve 141-2A and 142-2B, while stochastic failure of R1 relay may not be ruled out.
