The Station Blackout Incident of the Maanshan NPP unit 1

Atomic Energy Council

April 18, 2001

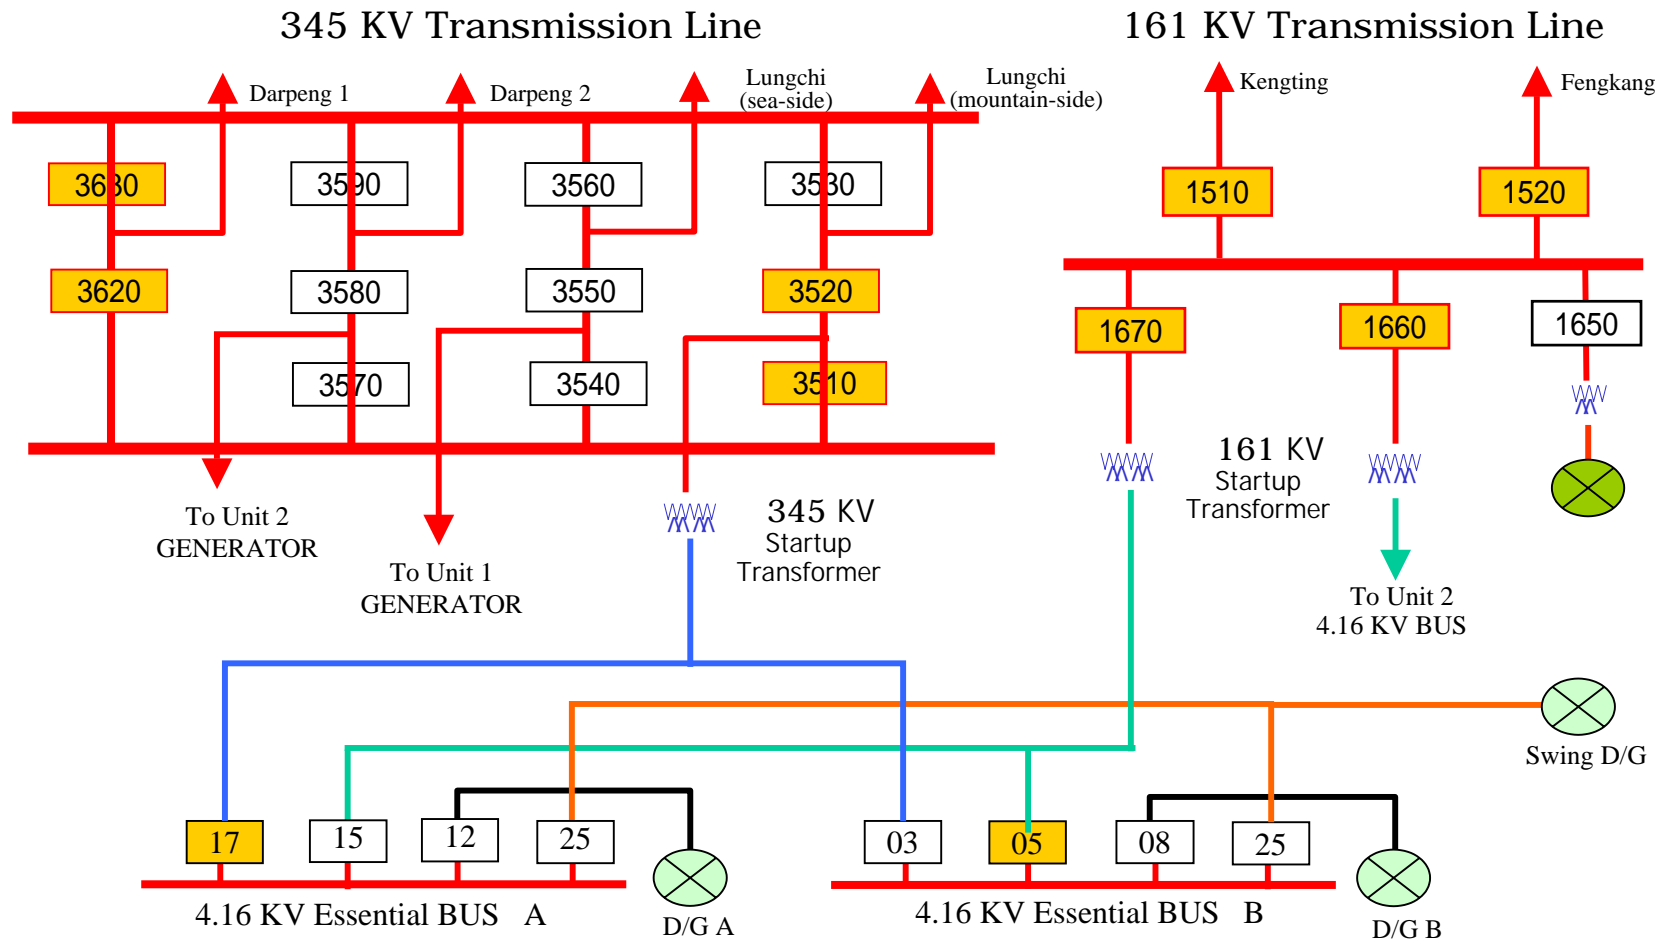
Figure 1: AC power distribution system of Maanshan NPP

The electric power distribution system of the Maanshan NPP is shown in Figure 1. The incident was initiated due to failure of the 4.16 KV essential buses at unit 1. The essential buses are consisted of two separate, redundant and independent power sources. In an event if one of the buses failed, the other bus could still provide the required AC power to ensure the plant safety. From the perspective of nuclear safety, the most important issue for the incident occurred is that why both essential buses lost offsite AC power at the same time, while the offsite 161 KV power source remained functionally available.

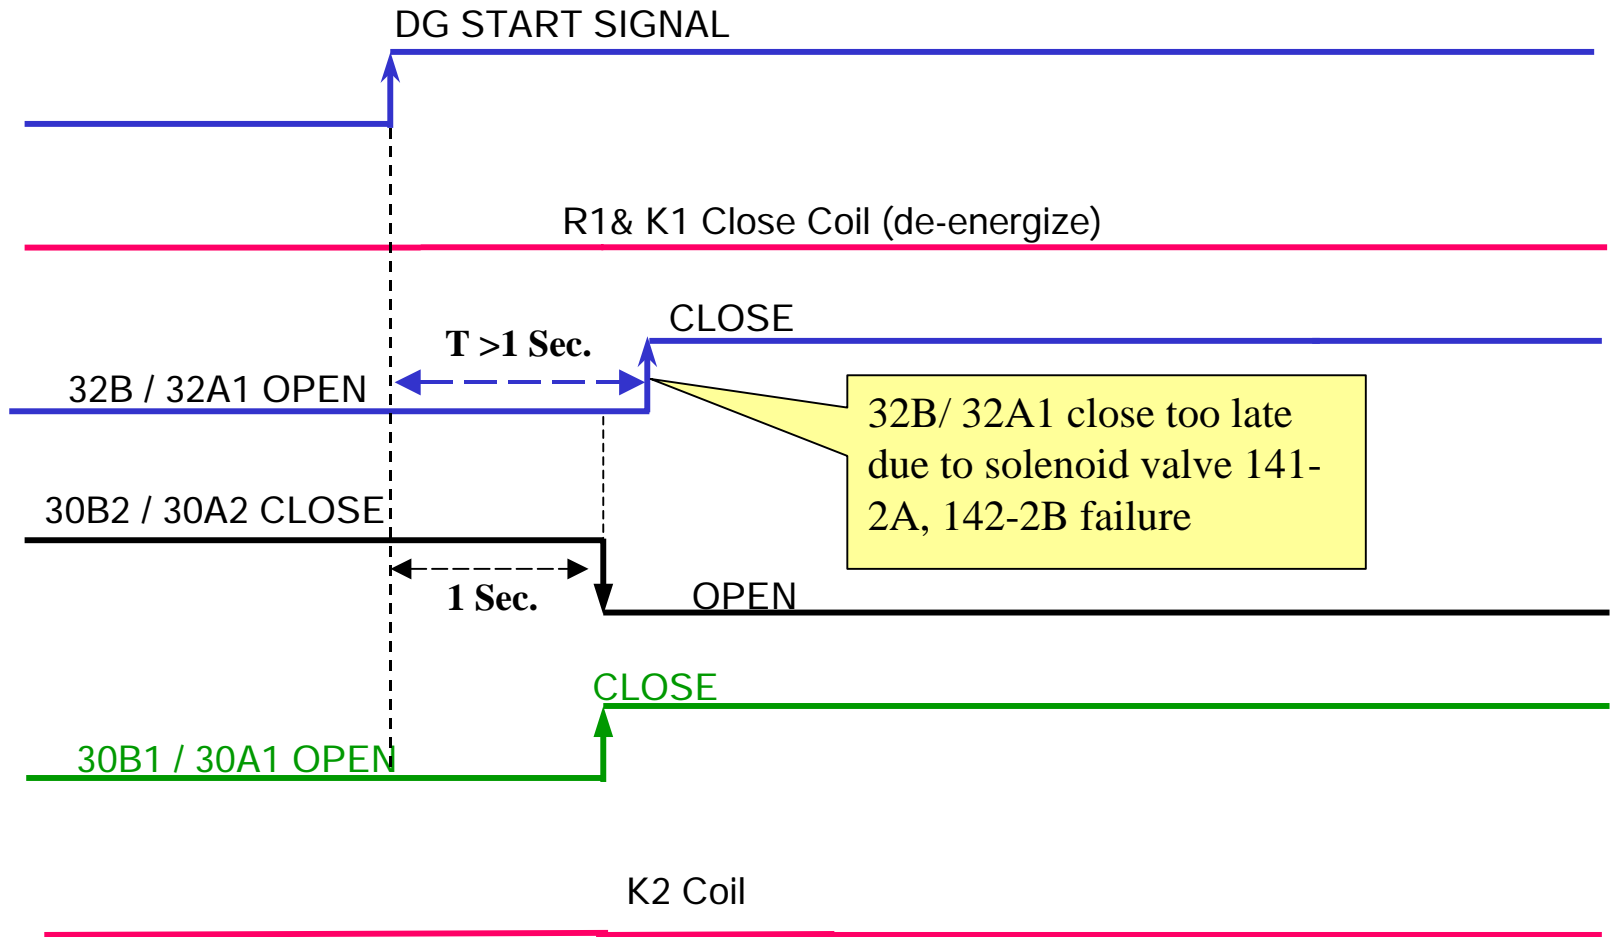
Figure 6: Timing sequence of EDG B excitation failure

designed, but cannot establish excitation to generate voltage (Figure 5). The EDG B did start up but fail to supply AC power. After the incident, plant staff restarted the EDG B at 12:50 March 18, it started up successfully and the excitation also functioned properly.

After the incident, Maanshan NPP staff repeatedly tested R1 and K1 relay control circuits of the EDG B. Among those tests, the safety signal from both train A and B are isolated and tested separately. The test results show that when train A was tested alone, the electric magnet valve 141-2A had little air leakage. When train B was tested alone, the electric magnet valve 142-2B did not work (Figure 6). But when both train A and B were tested simultaneously as designed, the EDG got proper excitation and functioned normally.

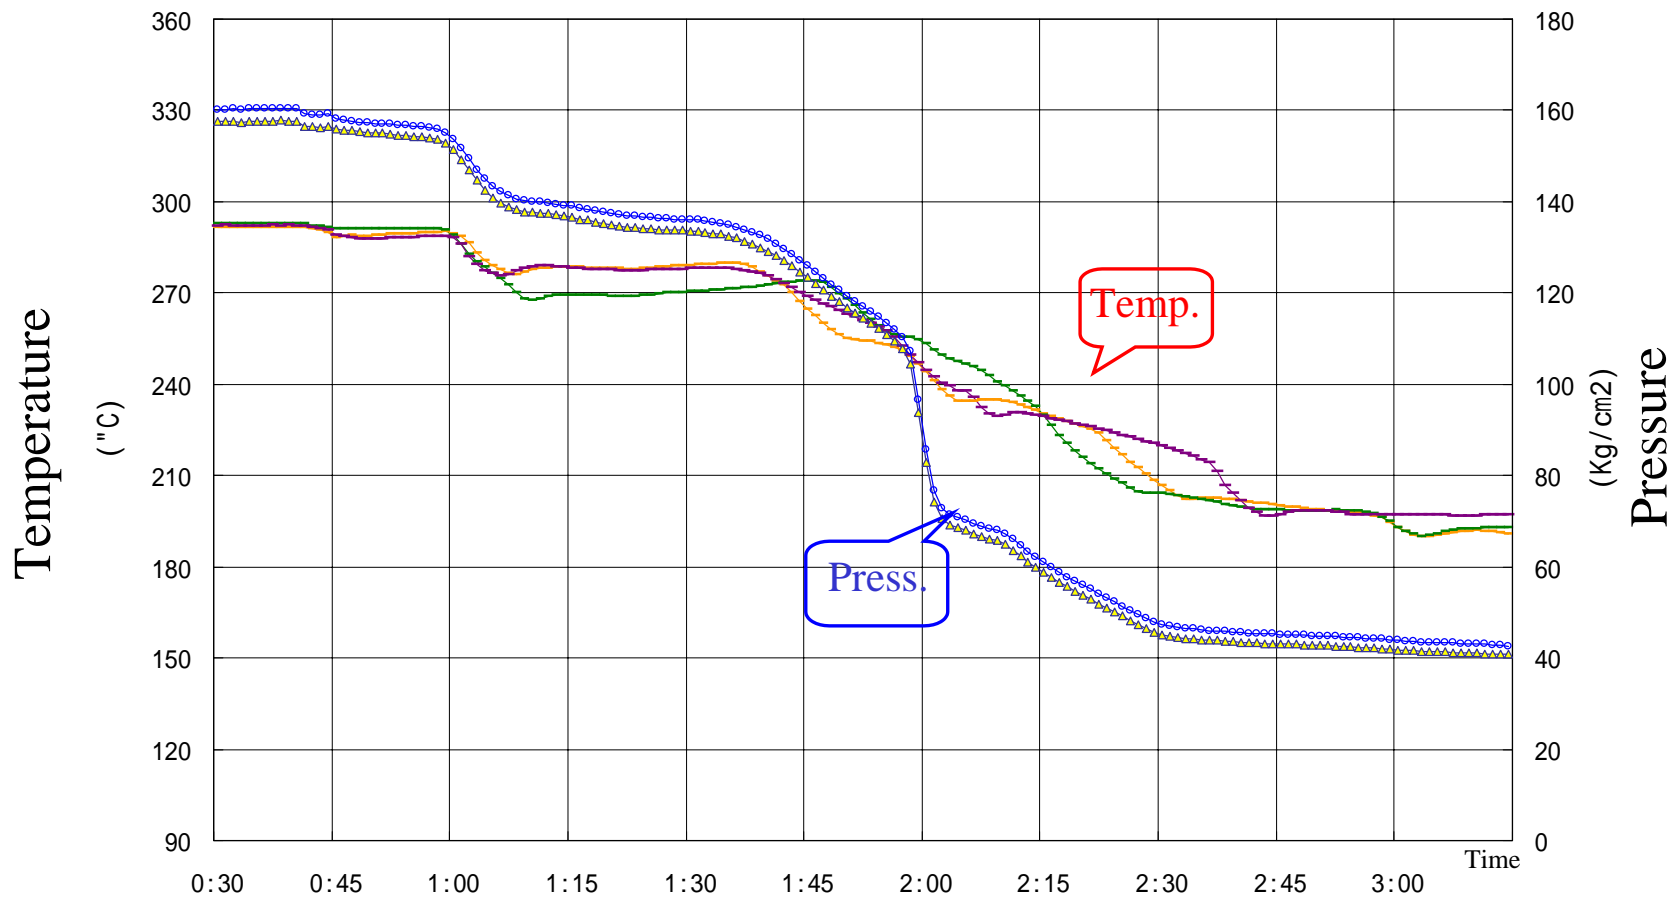
Figure 7: RCS Pressure & Temperature during Maanshan incident

shown in Figure 7). According to the level variation of coolant drain tank and containment floor sump, there was no sign of RCP seal leakage.

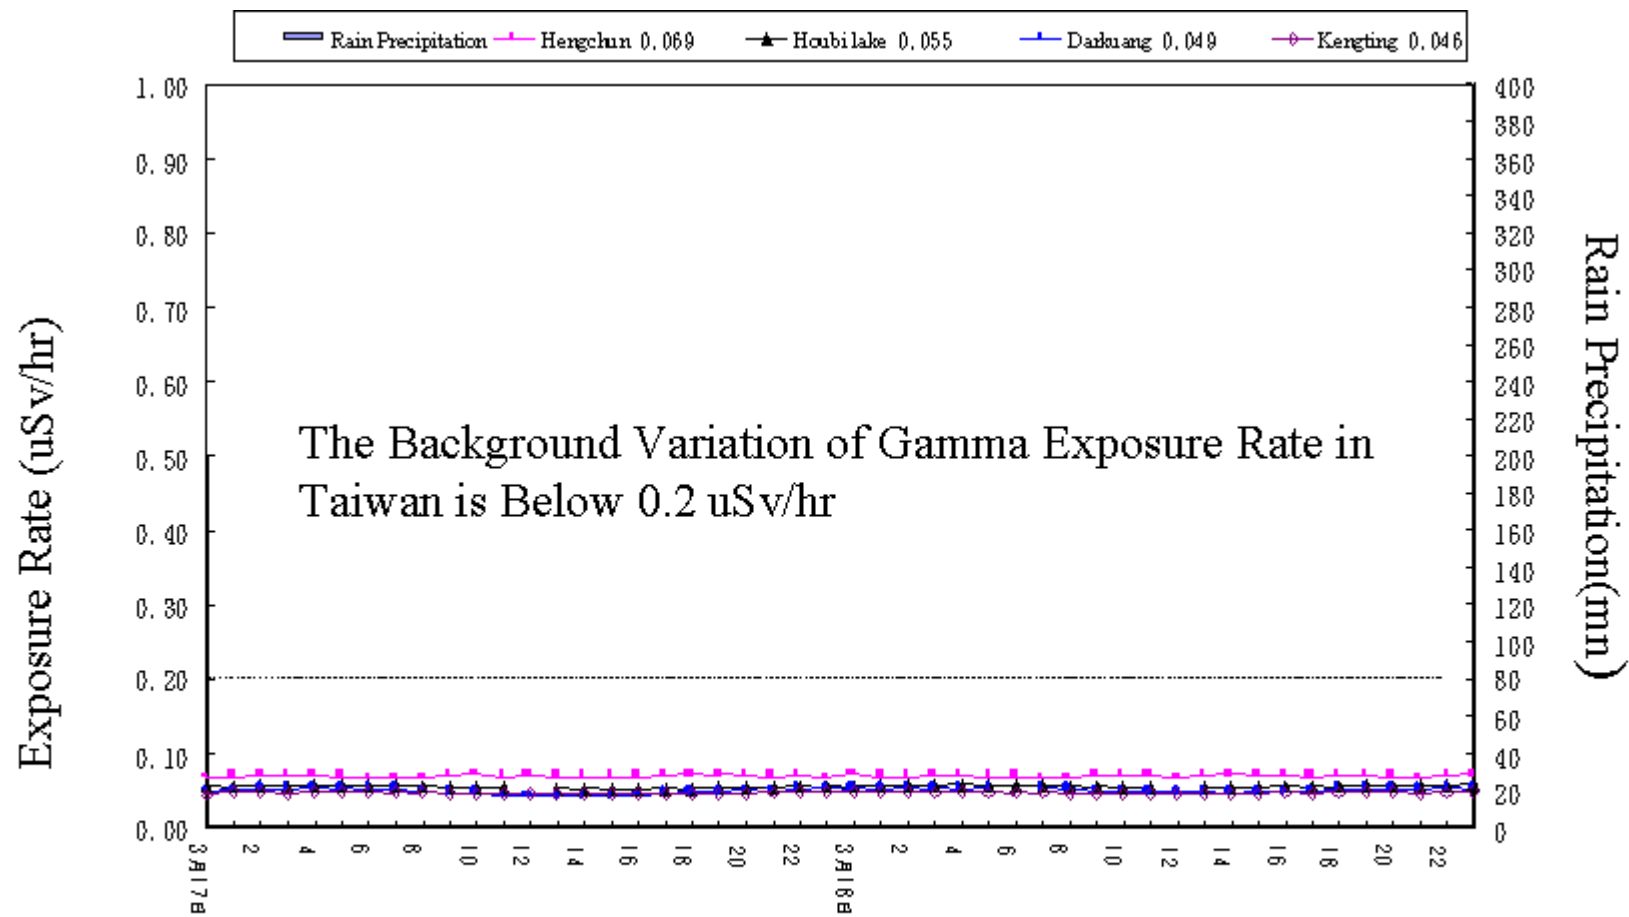
Figure 8 : The Average Gamma Exposure Rate Measured

Radiation Monitoring Center (RMC), a subsidiary of AEC, also has many HPIC gamma-ray detectors located on nearby local population center surrounding the Maanshan NPP. Those detectors can continuously record the environment radiation level. According to the data detected during March 17 to March 18, all radiation readings varied around background level (as shown in Figure 8).
